# MAIB

## FLYER TO THE LEISURE INDUSTRY

### OUZO:

### ACCIDENT WITH THREE FATALITIES 21 AUGUST 2006

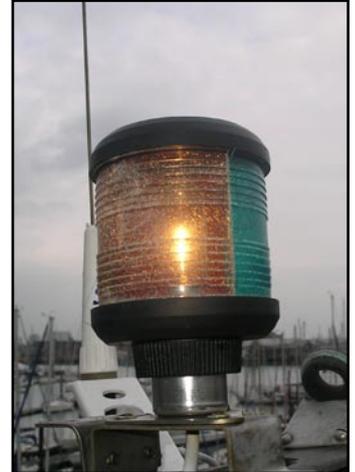
- i. The lenses of navigation light units similar to the one fitted to *Ouzo* are prone to crazing which substantially reduces their efficiency. **(as shown on photo)**

- ii. The lamps (bulbs) fitted to the navigation lights used on *Ouzo* can easily be inadvertently replaced with lamps of a lower rating.
  - iii. It is quite common for replacement lamps for yacht navigation lights to have damaged filaments, which cause an intermittent fault.

- iv. If the yacht heels more than 5° the horizontal intensity of her navigation lights may be decreased.

**Yacht owners should make every effort to ensure that their navigation lights are fully effective, and their characteristics understood.**
