# MAIB

## FLYER TO THE LEISURE INDUSTRY

### OUZO:

### ACCIDENT WITH THREE FATALITIES 21 AUGUST 2006

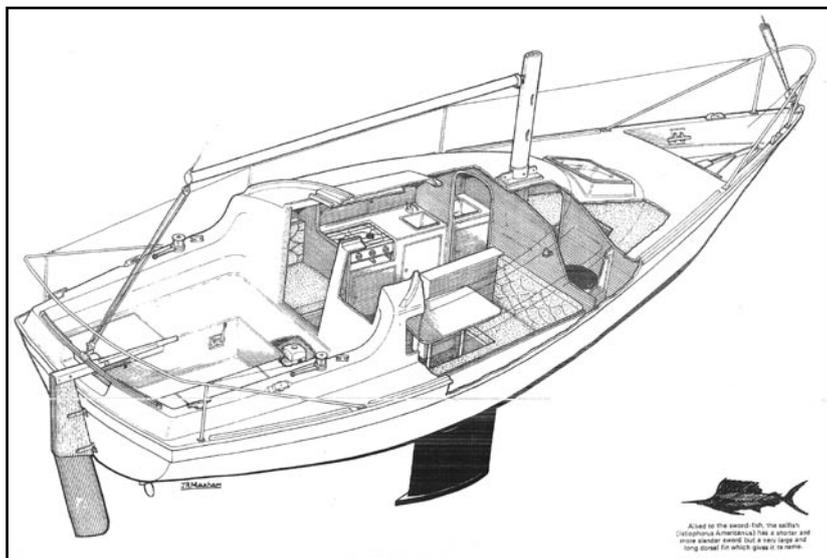
The yacht *Ouzo* sailed from Bembridge, Isle of Wight (IOW), bound for Dartmouth, Devon on the evening of 20 August 2006 with her three regular crew on board. The last record of the yacht was at 2230 when she went out of range of the Southampton/Portsmouth VTS radar system in Sandown Bay. At this time it is believed that the yacht was sailing close hauled in a south-south-westerly direction.

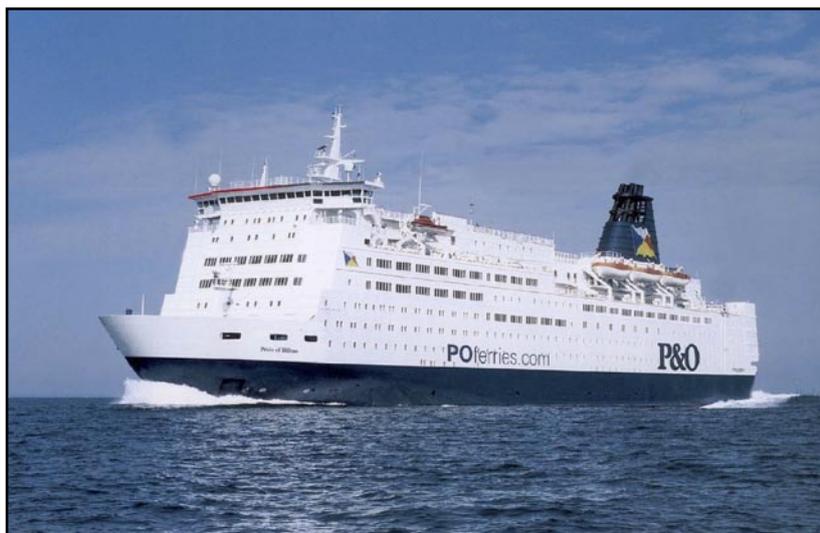
Voyage data recorder (VDR) records from ships that had been in the area during the night of 20/21 August were recovered and analysed by MAIB inspectors and it was discovered that the ferry *Pride of Bilbao* had been involved in an incident with a yacht 6 miles south of the Isle of Wight in the early hours of 21 August. The investigation concluded that she had either collided with, or passed so close to *Ouzo* at that time, and that the yacht had been swamped or capsized by the vessel's wash.
